BOLT CERTIFIED HOME INSPECTION

THE BOLT REPORT

7 Independence Ct
Greensboro, NC 27408

JANUARY 5, 2025

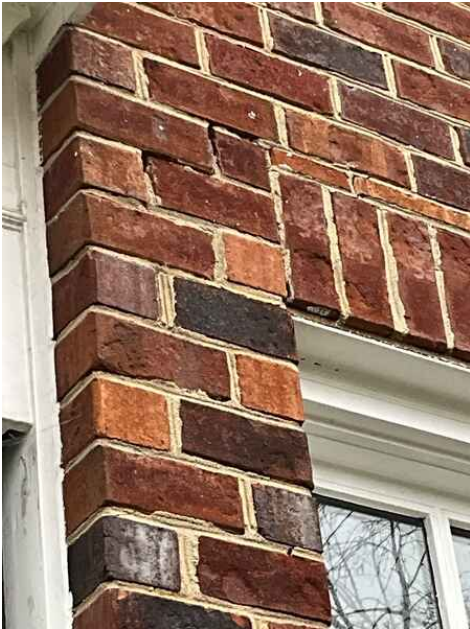
CRACKING - MINOR

Brick veneer showed cracking in one or more places. Recommend monitoring.

Recommended DIY Project

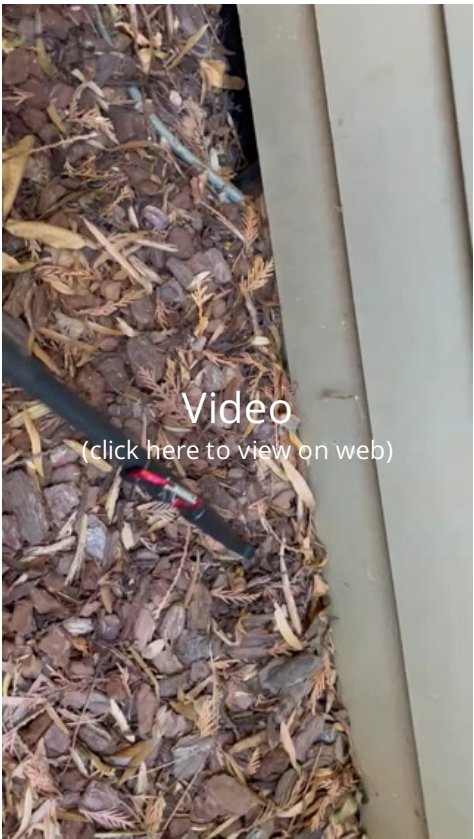
INADEQUATE GROUND CLEARANCE

Correction and further evaluation is recommended.

Contact a qualified siding specialist.

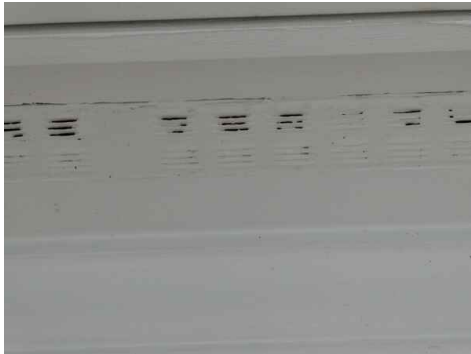
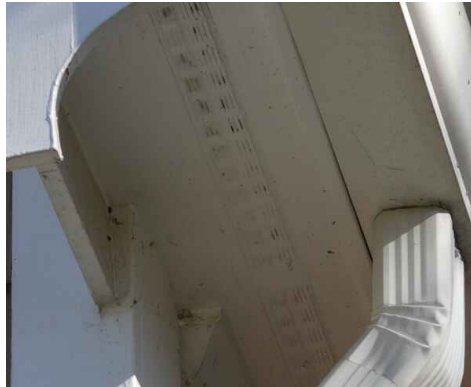
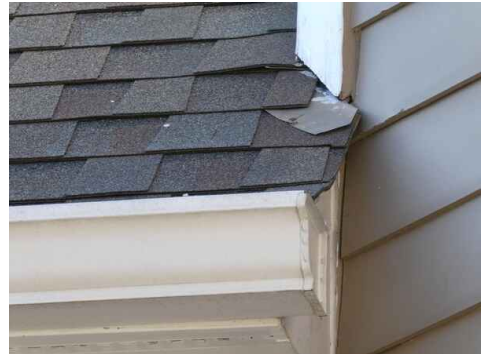
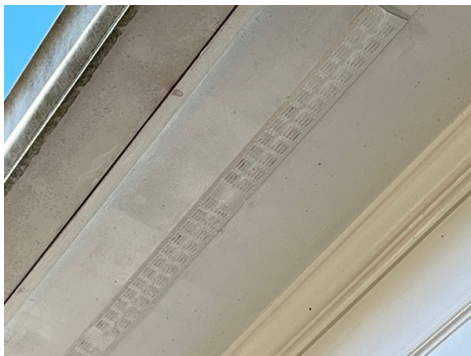
DAMAGE OBSERVED AT SOFFIT

I observed indications that one or more areas of the soffit were damaged with paint clogging the soffit vent in several locations.

Correction and further evaluation is recommended.

Contact a qualified roofing professional.

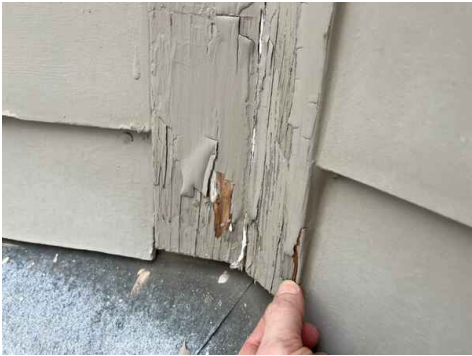
PAINT SURFACE IN POOR CONDITION

I observed indications of paint or staining in poor condition. Flaking, cracking, and worn areas.

Correction and further evaluation is recommended.

Contact a qualified painting contractor.

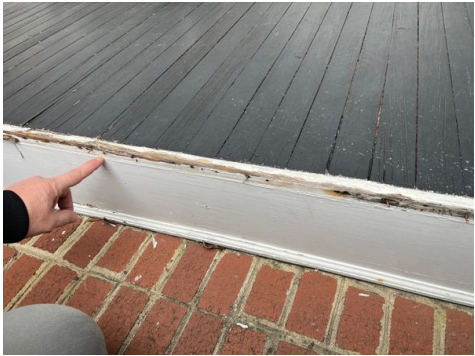
Outside Of 2nd Floor Hallway Window, Back Of House

WOOD ROT AT WINDOW

I observed indications of wood rot at the window.
Correction and further evaluation is recommended.

Recommendation
Contact a qualified window repair/installation contractor.

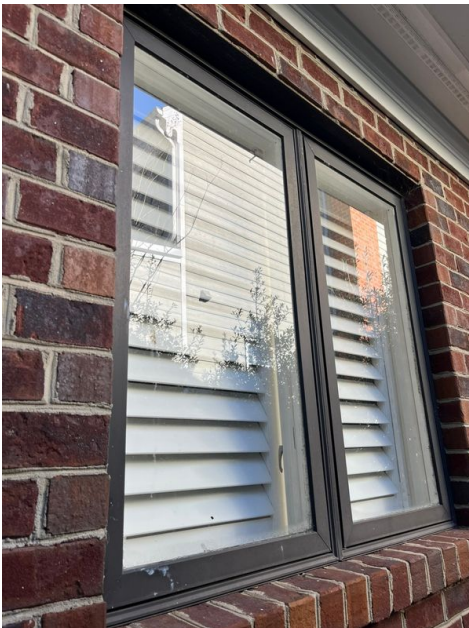
I observed a fogged windowpane (a lost seal) at a window.

If multiple-pane windows appear misty or foggy, it means that the seal protecting the window assembly has failed, and condensation has formed in between the two panes of glass. Condensation in double-paned windows indicates that the glazing assembly has failed and needs repair or replacement. Visible condensation can damage glazing and is the main indication of sealant failure. Condensation is not always visible. If the failure is recent, a failed window may not be obvious, since condensation doesn't usually form until the window is heated by direct sunlight. Windows in the shade may show no evidence of failure, so it is nearly impossible to observe and report all failed double-paned windows.

Contact a qualified window repair/installation contractor.

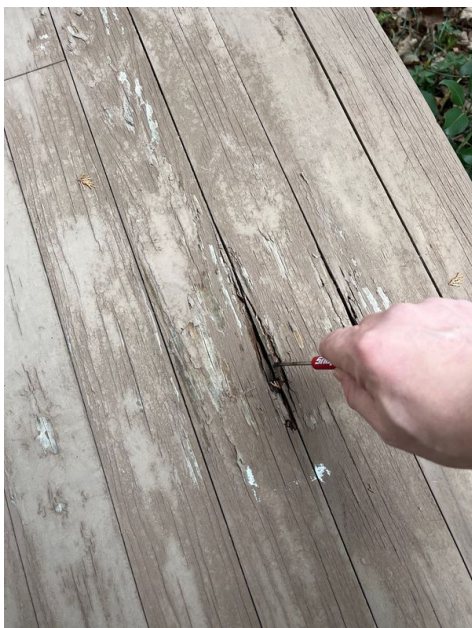
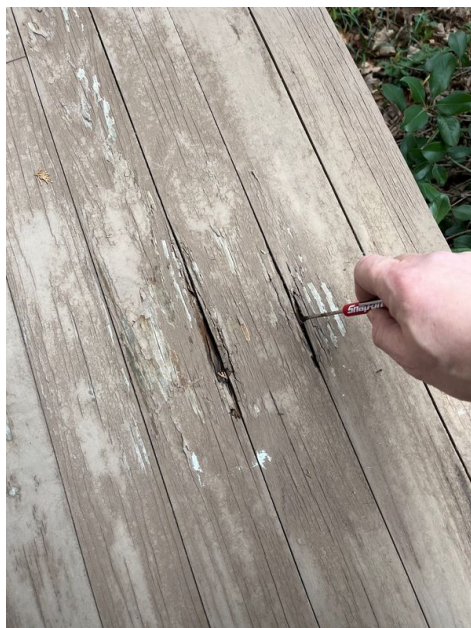
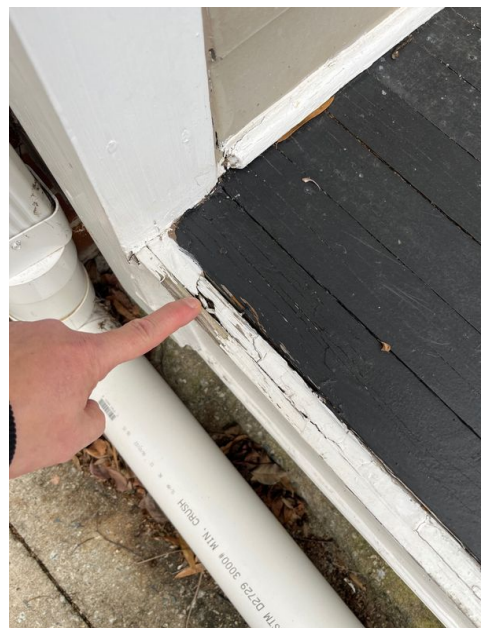
DECK - WOOD ROT

I observed wood rot at the deck. This condition is a structural defect.

Correction and further evaluation of the deck is recommended.

Contact a qualified deck contractor.

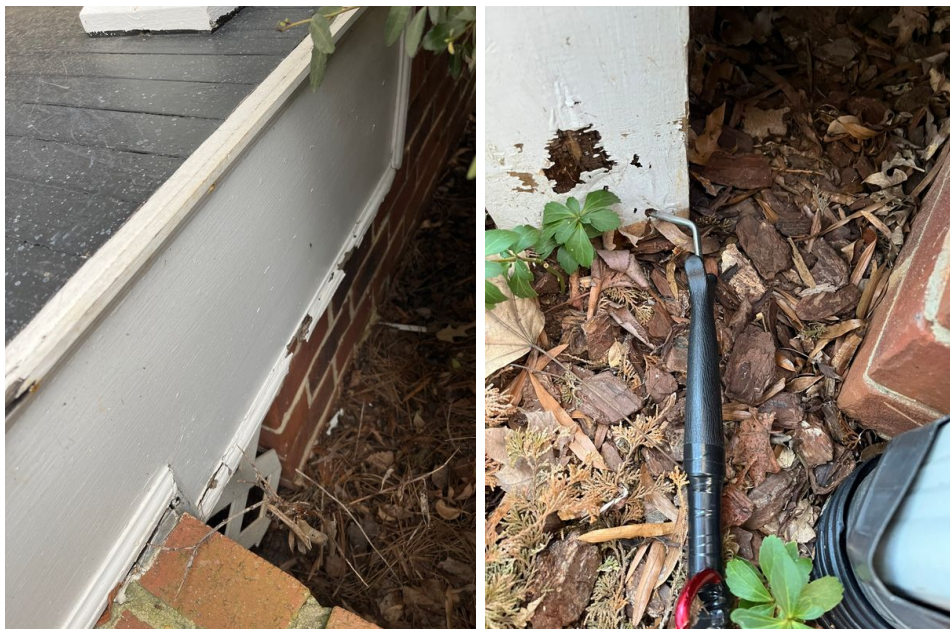
Grading is sloping towards the home in some areas. This could lead to water intrusion and foundation issues.

The ground around a house should slope away from all sides, ideally 6 inches for the first 10 feet from the house foundation perimeter. Downspouts, surface gutters and drains should also be directing water away from the foundation.

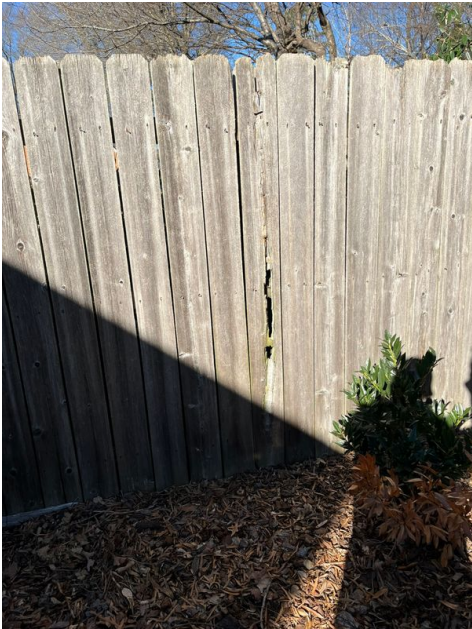
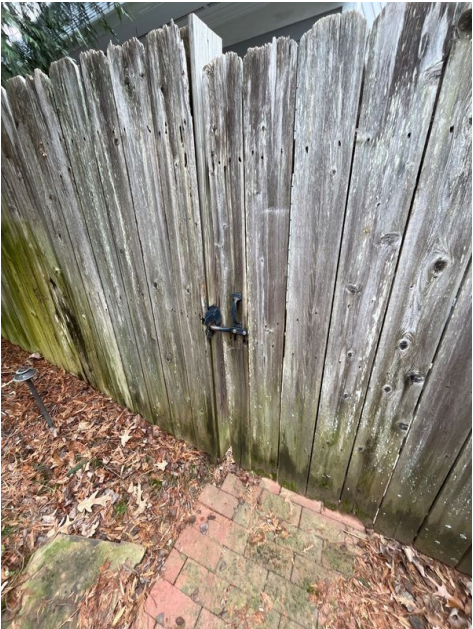
FENCE DEFECT

I observed that the condition of the fence in many areas is poor.

Contact a qualified fencing contractor

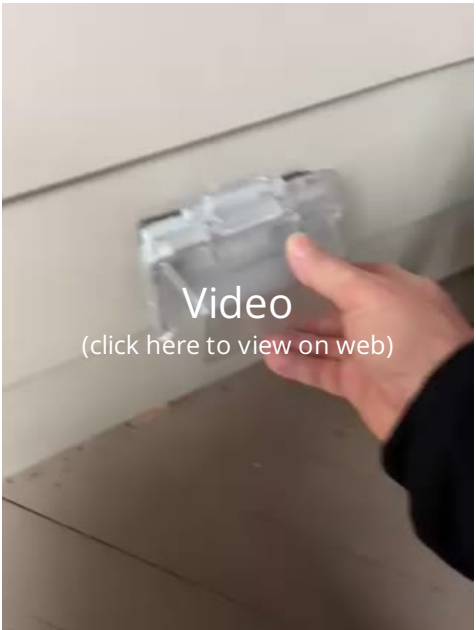
LOOSE BOX ON EXTERIOR OUTLET

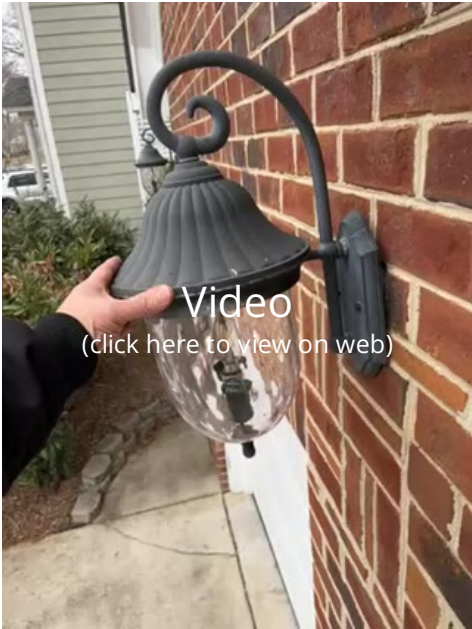
LOOSE LIGHT FIXTURE

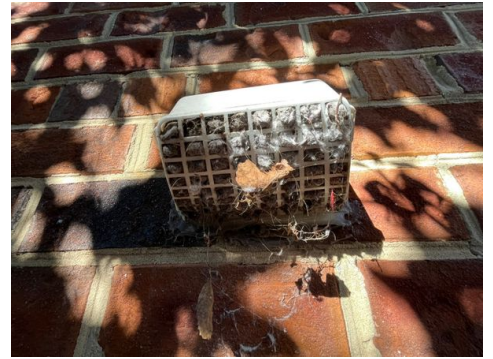
I observed that the clothes dryer exhaust hood has a screen. This will clog and create a fire hazard.

Recommended DIY Project

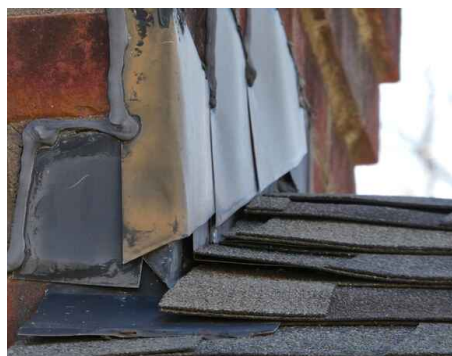
Chimney: Chimney Flashing Was Inspected

The flashing around the chimney was inspected.

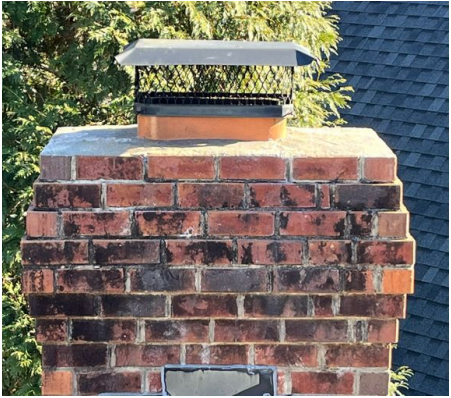
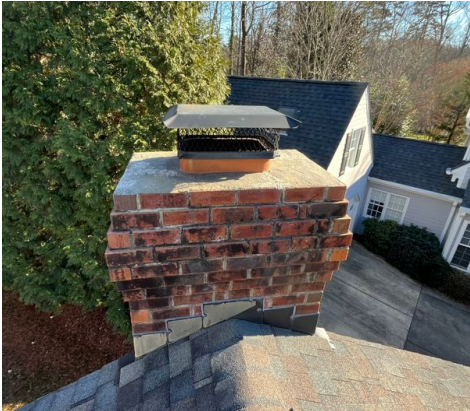
Chimney: Chimney Cap Installed

A chimney cap was installed at the top of the chimney. Good.

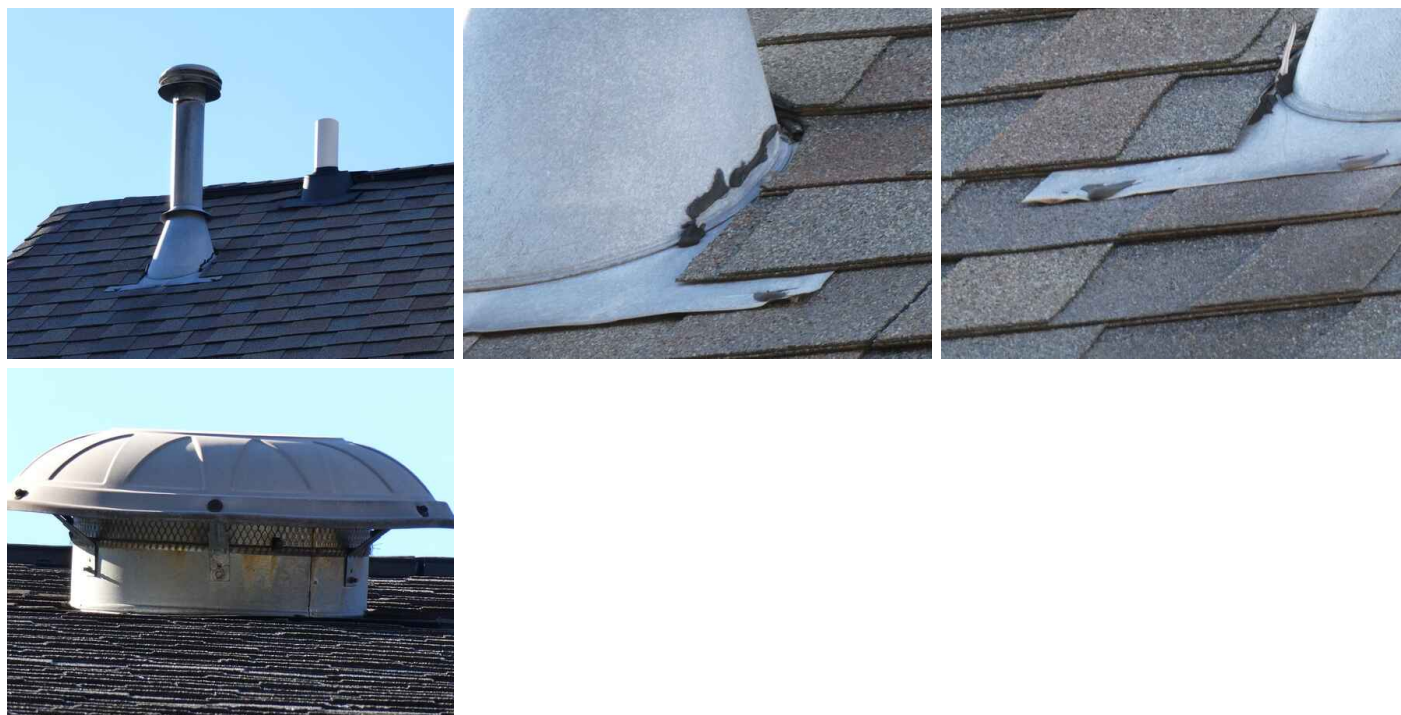
Plumbing Vent Pipes: Plumbing Vent Pipes Inspected

I looked at DWV (drain, waste, and vent) pipes that pass through the roof covering. There should be watertight flashing (often black rubber material) installed around the vent pipes. These plumbing vent pipes should extend far enough above the roof surface.

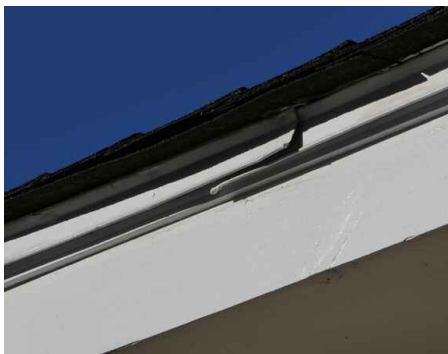
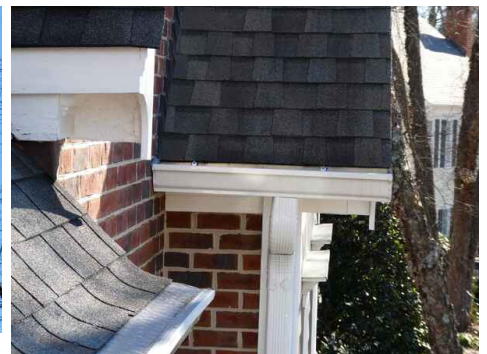
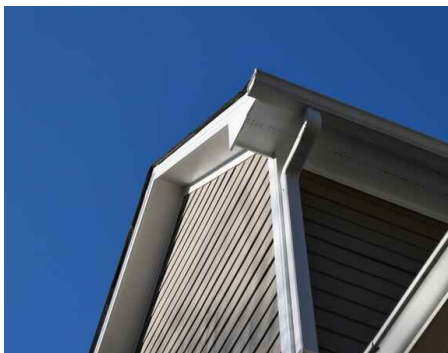
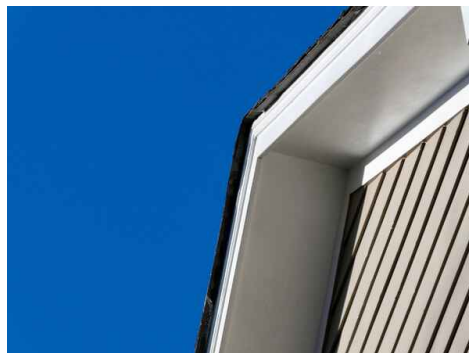
Flashing: Eaves and Gables, partial drip edge

I looked for flashing installed at the eaves (near the gutter edge) and at the gables (the diagonal edge of the roof). There should be metal drip flashing material installed in these locations but it was only seen on portions of the roof at the back of the house. The flashing helps the surface water on the roof to discharge into the gutter. Flashing also helps to prevent water intrusion under the roof-covering.

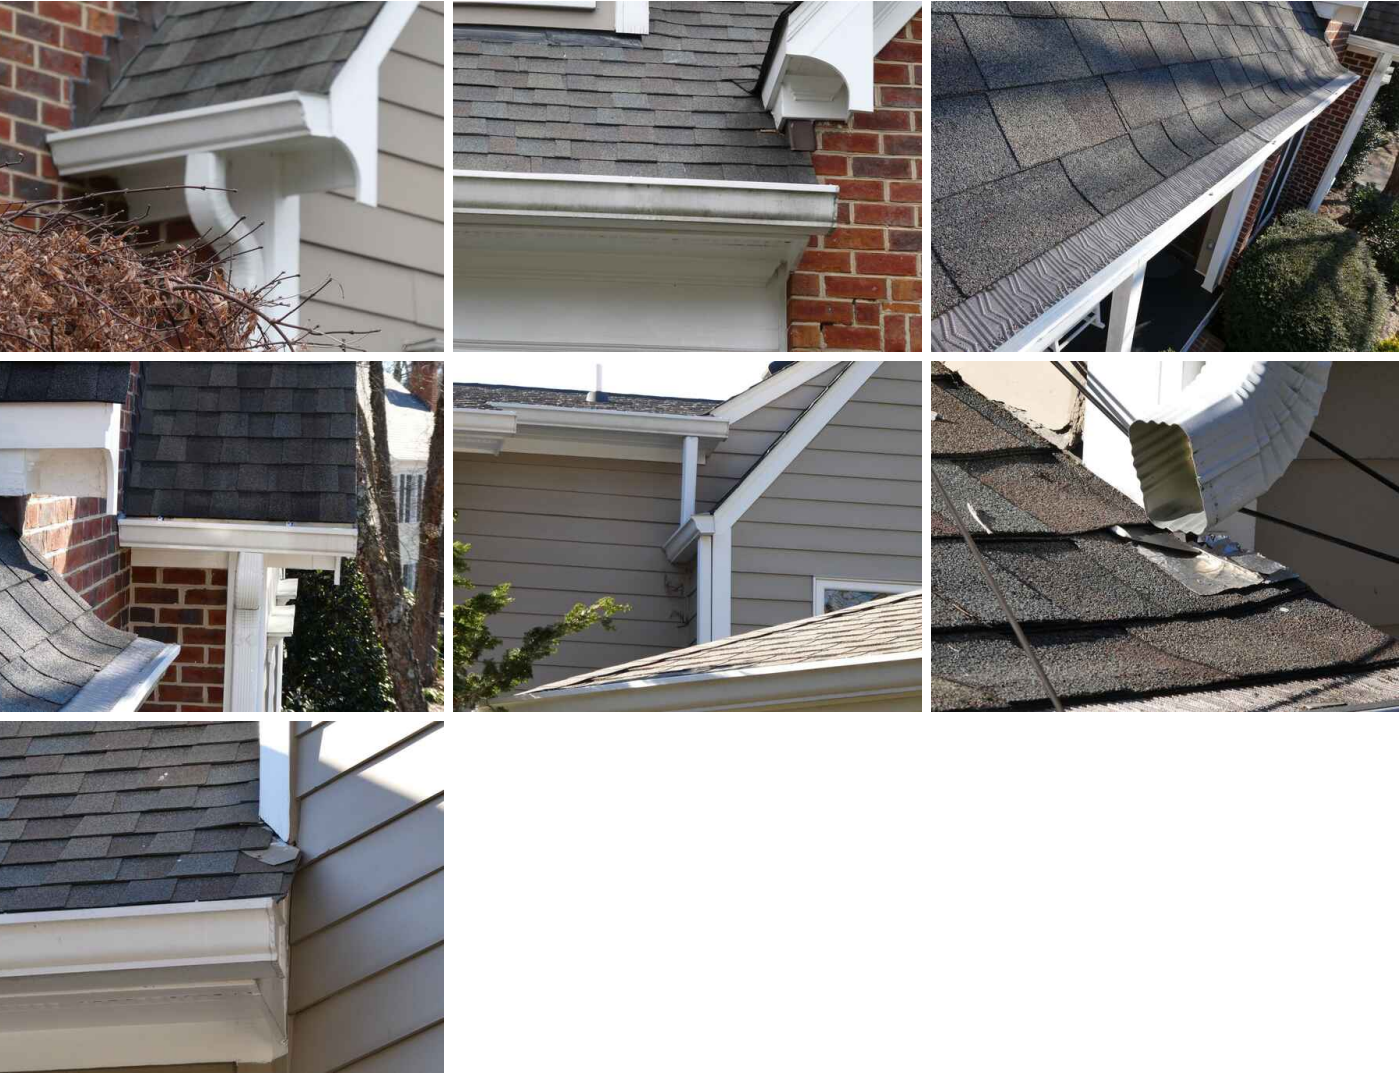
Gutters & Downspouts: Gutters Were Inspected

I inspected the gutters and there have been some improvements made since the inspection done in 2022. The gutters now have debris screens and appear to be in good repair. I wasn't able to inspect every inch of every gutter. However, I attempted to check the overall general condition of the gutters during the inspection and look for indications of major defects.

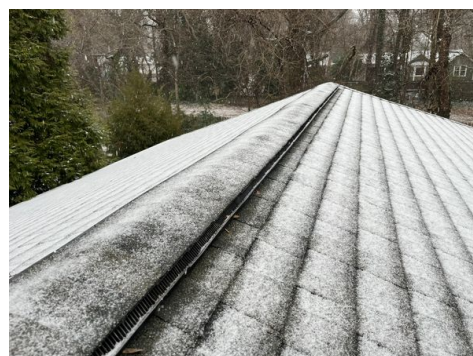
SNOW COVERING THE ROOF

There was snow covering the roof surface. This was an inspection restriction. I was unable to observe everything that I needed to see because of the snow. I recommend further evaluation at a later date when the snow has melted.

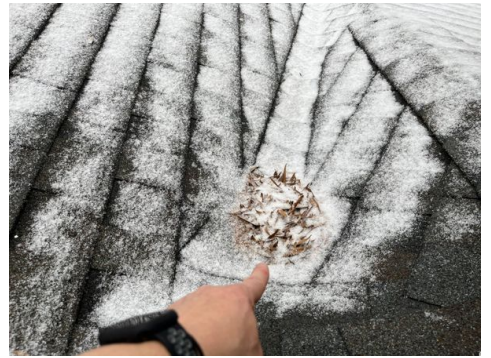
Debris was observed on the roof, which can obstruct proper roof drainage and increase the risk of gutter clogging. This condition may lead to water pooling, leaks, or damage to the roof and surrounding structures. It is recommended to have the debris removed and the roof and gutters cleaned by a qualified professional to ensure proper drainage and prevent further issues.

Contact a qualified gutter contractor

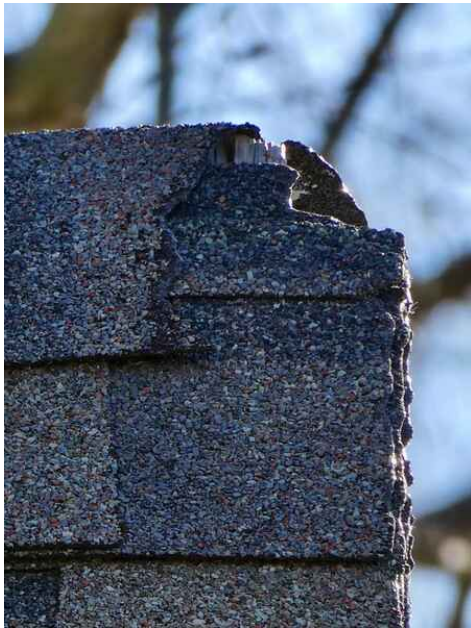
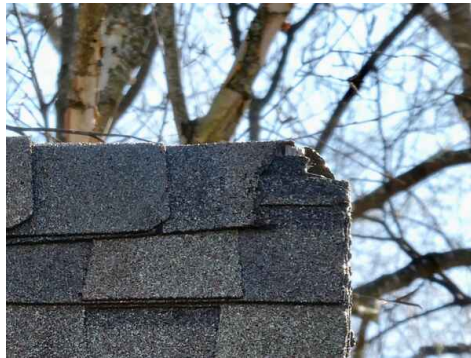
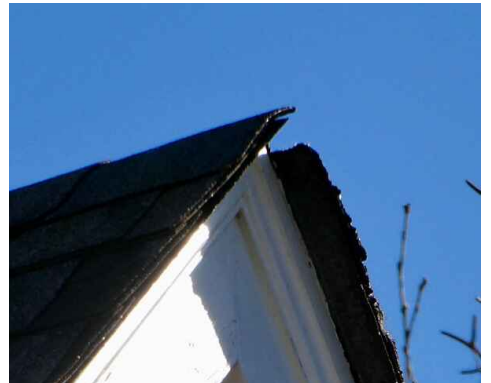
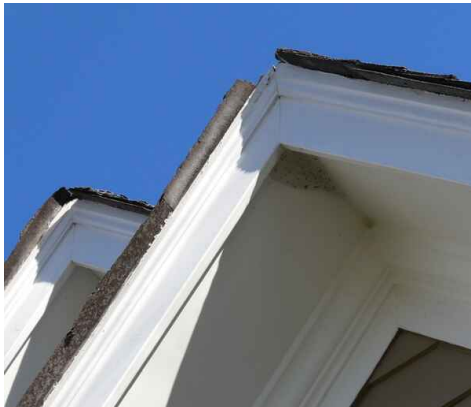
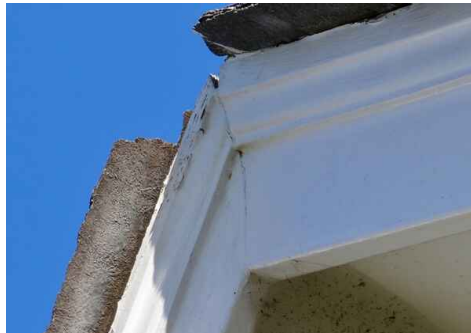
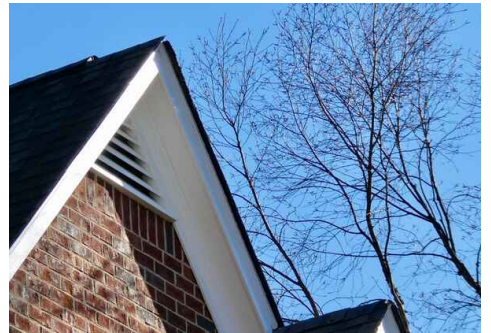
MISSING ROOF-COVERING MATERIAL

I observed missing roof-covering material. Bad. Prone to leaking. It could be leaking right now or during the next rain. If it's not corrected, it could cause damage and mold problems. Correction and further evaluation by a professional roofer is recommended.

Contact a qualified roofing professional.

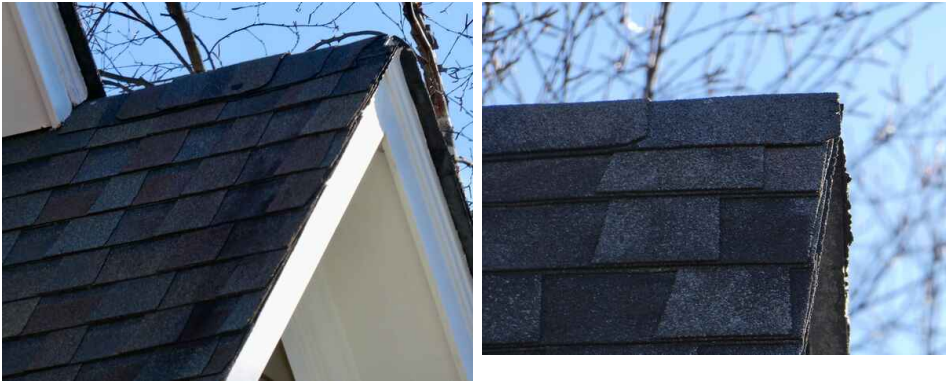
EXPOSED FASTENERS

I observed indications of exposed fasteners at the roof-covering materials. Fasteners should not be exposed. Potential water entry points. Bad. Prone to leaking. It could be leaking right now or during the next rain. If it's not corrected, it could cause damage and mold problems. Correction and further evaluation by a professional roofer is recommended.

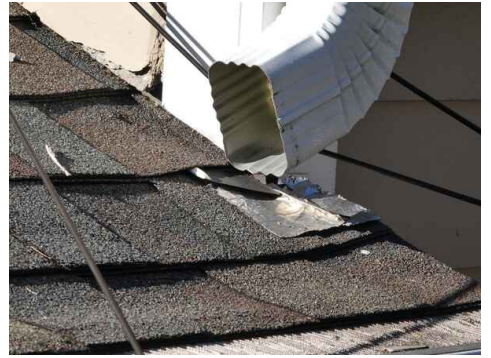
4.1.4 Roof Covering

INSTALLATION DEFECT AT ROOF COVERING

I observed indications of improperly installed roof-covering materials. Also the gutter should not discharge directly onto the shingles. This is not according to best practices or common standards. Bad. Prone to leaking. It could be leaking right now or during the next rain. If it's not corrected, it could cause damage and mold problems. Correction and further evaluation by a professional roofer is recommended.

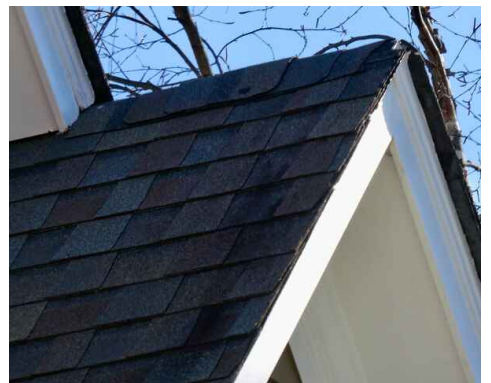
4.1.5 Roof Covering

DISCOLORATION STAIN FROM ALGAE

I observed indications of staining and discoloration on the roof-covering materials. This condition seemed to have been caused from algae. What we commonly call algae is actually not algae, but a type of bacteria capable of photosynthesis. Algae appeared as dark streaks, which are actually the dark sheaths produced by the organisms to protect themselves from UV radiation. When environmental conditions are right, the problem can spread quickly across a roof.

Monitoring this condition is recommended.

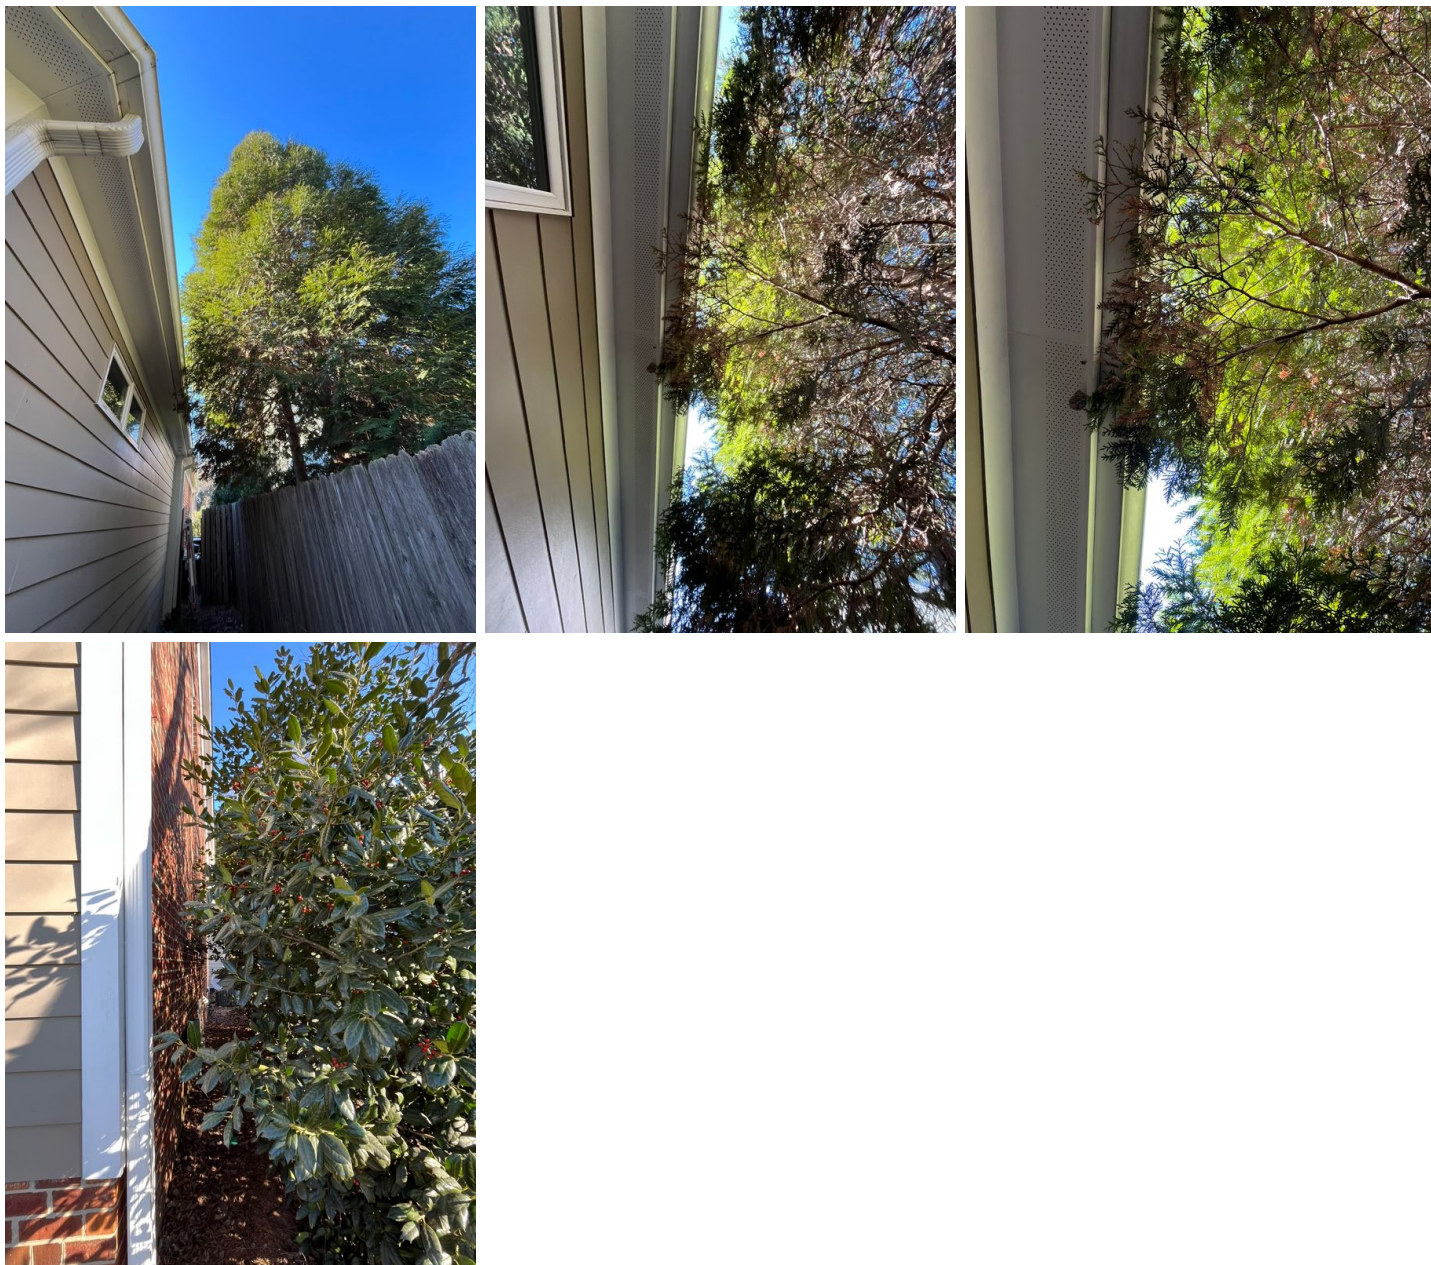
4.1.6 Roof Covering

TREE TOO CLOSE

I observed indications that a tree and/or tree branch were located near the roof system, overhanging the roof and possibly in contact with it. The tree may cause damage if it has not already. Bad. If not corrected, a roof leak resulting from this condition could cause structural damage and mold problems. Correction and further evaluation by a professional roofer is recommended.

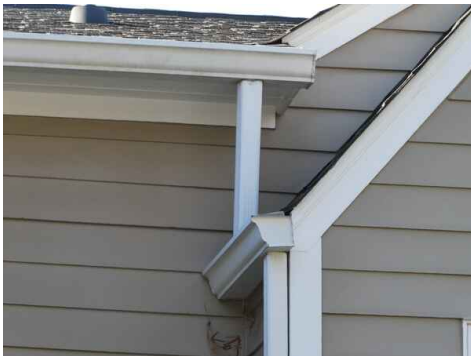
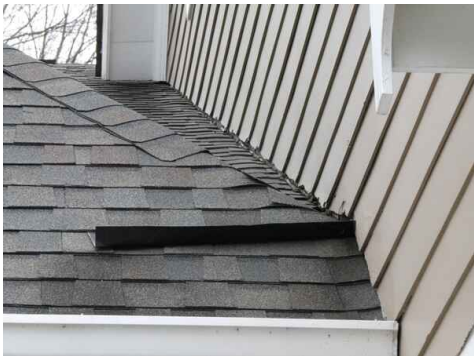
4.3.1 Flashing

MISSING KICKOUT FLASHING

I observed a defect at the flashing area called a "kickout." It was missing. Not installed. A kickout flashing "kicks" the roof water away from the house structure and diverts it into a gutter. This missing flashing could lead to hidden moisture intrusion and water damage issues that I would not be able to observe during a visual-only home inspection. Bad. If not corrected, a roof leak resulting from this condition could cause structural damage and mold problems. Correction and further evaluation by a professional roofer is recommended.

Contact a qualified roofing professional.

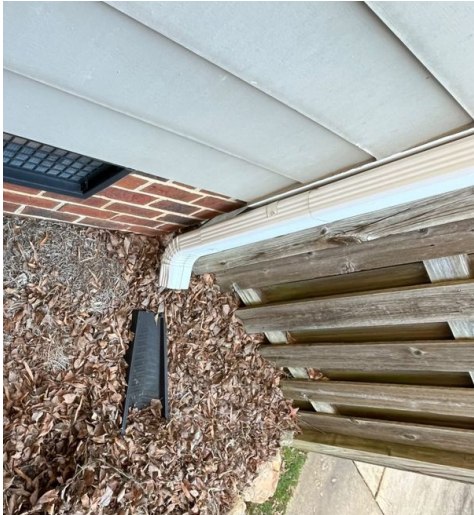
4.4.1 Gutters & Downspouts

I observed indications that the water diverter tray or splash block at the downspout end needed improvement. Easy to do. Cleaning and maintenance of the exterior, including the roof, gutters, and downspouts, are recommended. Water management is needed. Correction and further evaluation is recommended.

Recommendation
Recommended DIY Project

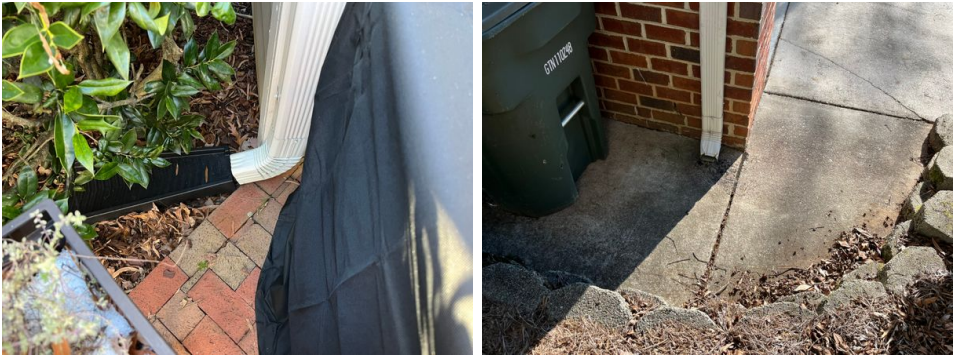
4.4.2 Gutters & Downspouts

One or more downspouts drain too close to the home's foundation. This can result in excessive moisture in the soil at the foundation, which can lead to foundation/structural movement. Recommend a qualified contractor adjust downspout extensions to drain at least 6 feet from the foundation. A handy homeowner should be able to do this project.

Recommendation
Recommended DIY Project

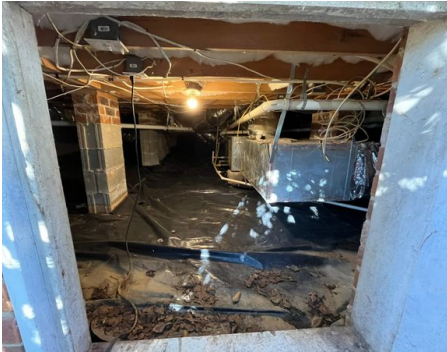
Main crawlspace entrance, right side of house

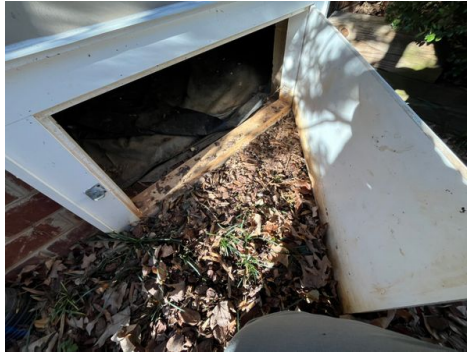
Additional crawlspace in the back of house

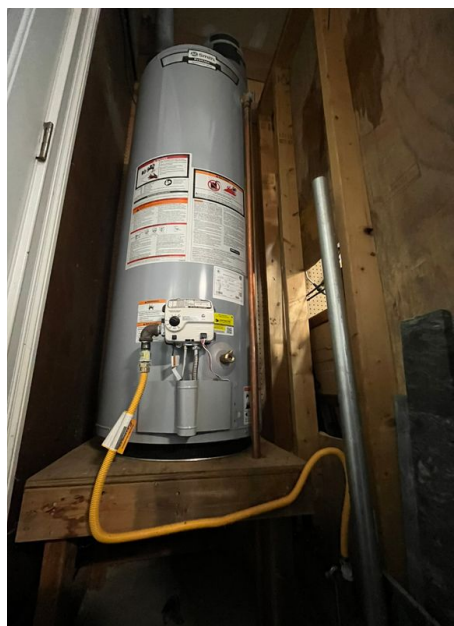
Missing pan.

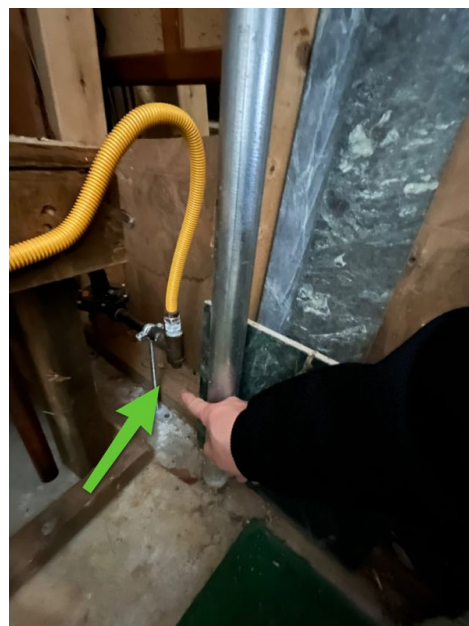
Missing sediment trap.

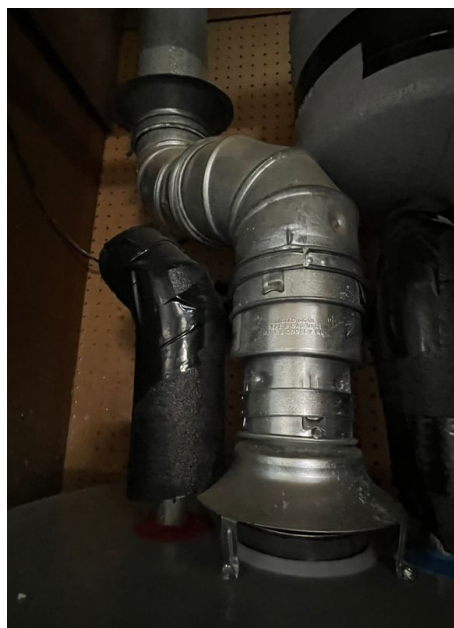
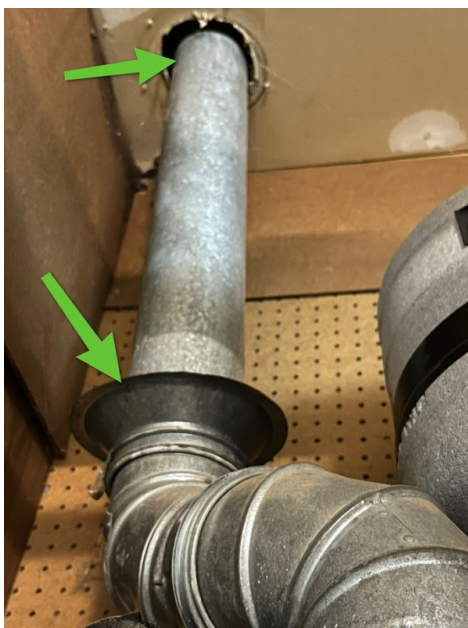
I inspected the venting connections. The boot has slid down and should be placed back at the ceiling.

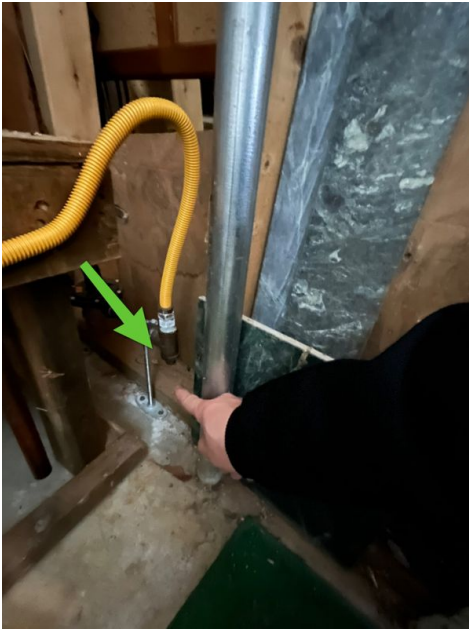
Missing sediment trap on gas line to water heater.

Contact a qualified professional.

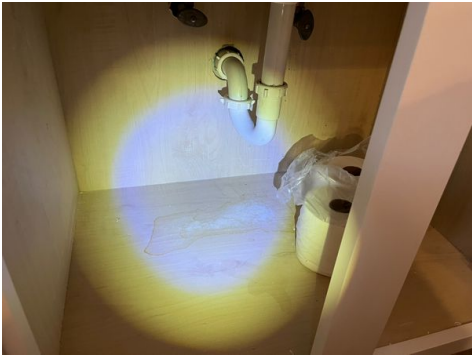
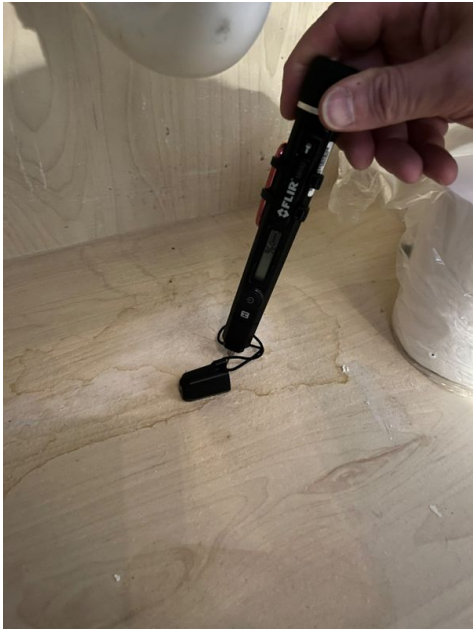
WATER DAMAGE AT CABINET SHELF

I observed indications of water damage at the bottom shelf of the bathroom cabinet, under the sink. Indication of a prior water leak.

Recommended DIY Project

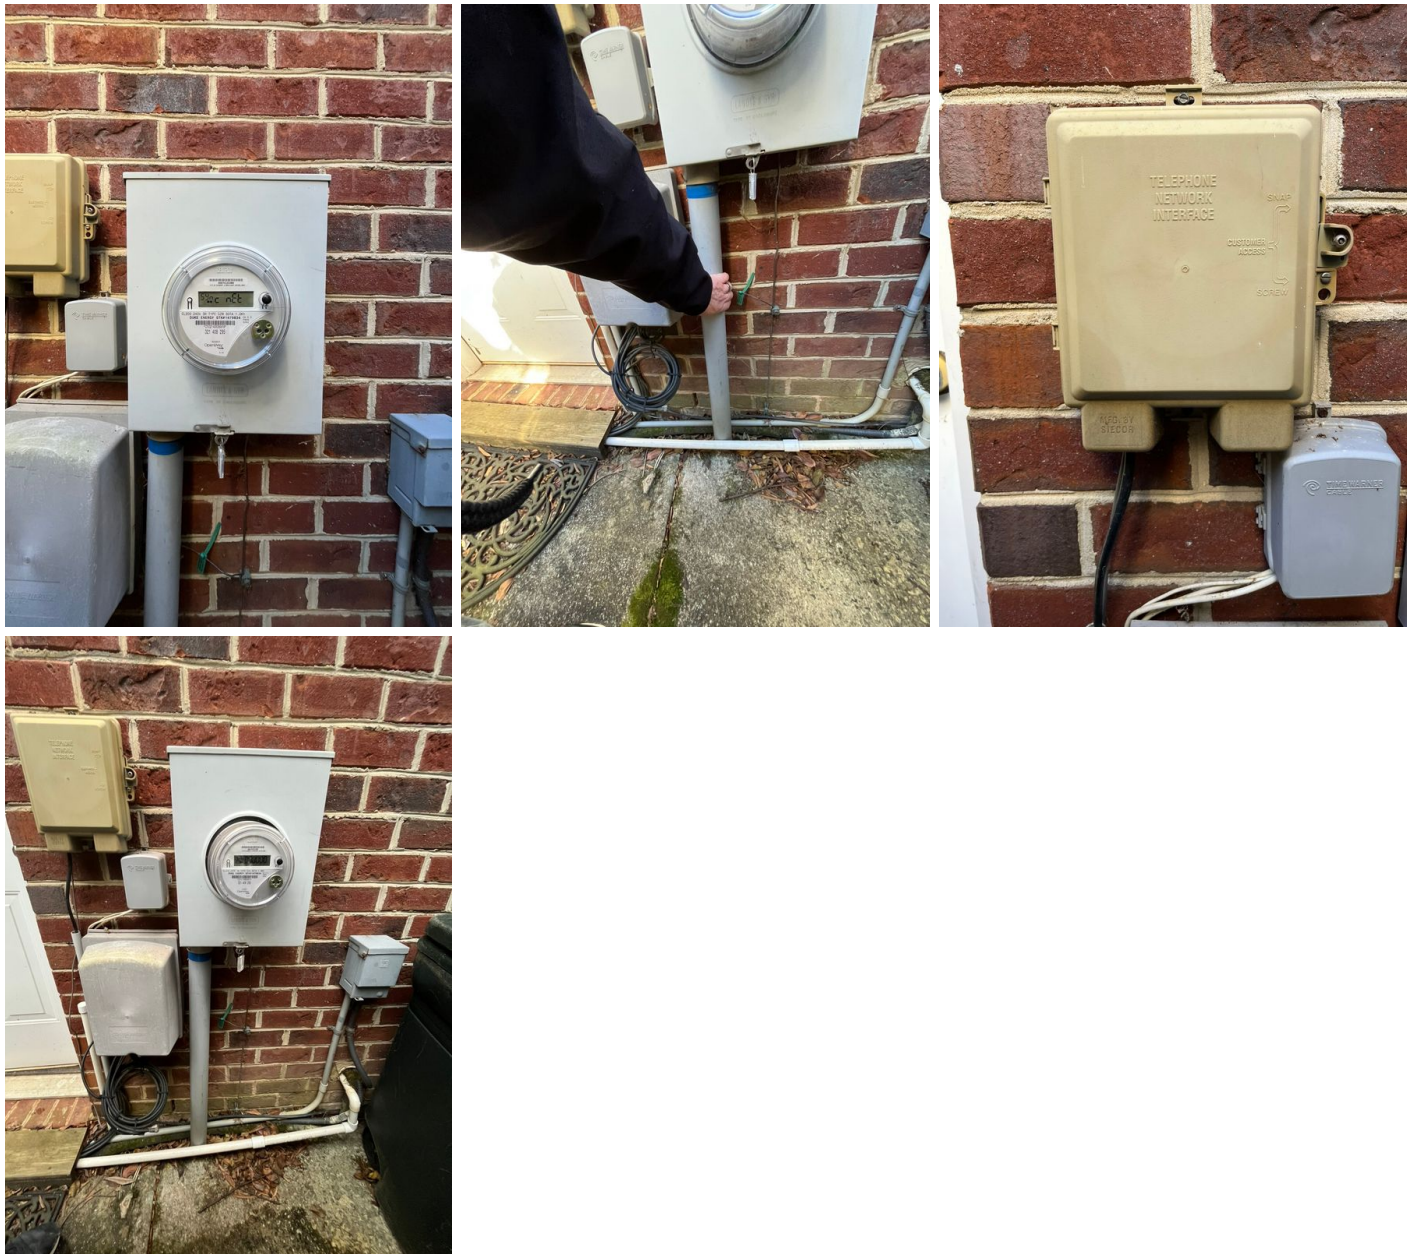
Left side of house

I inspected the electrical electric meter and base.

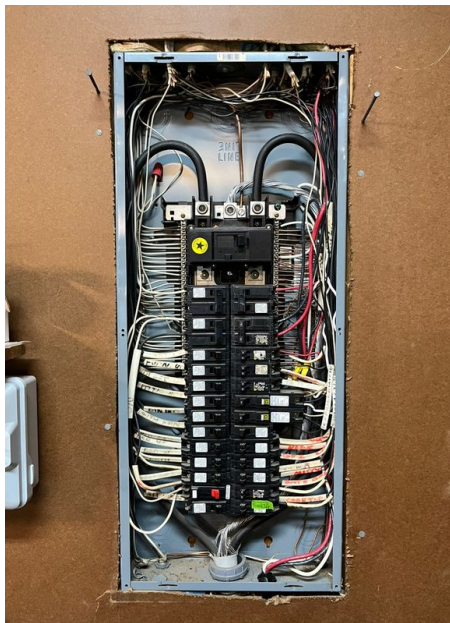
I inspected the electrical panelboards and over-current protection devices (circuit breakers and fuses).

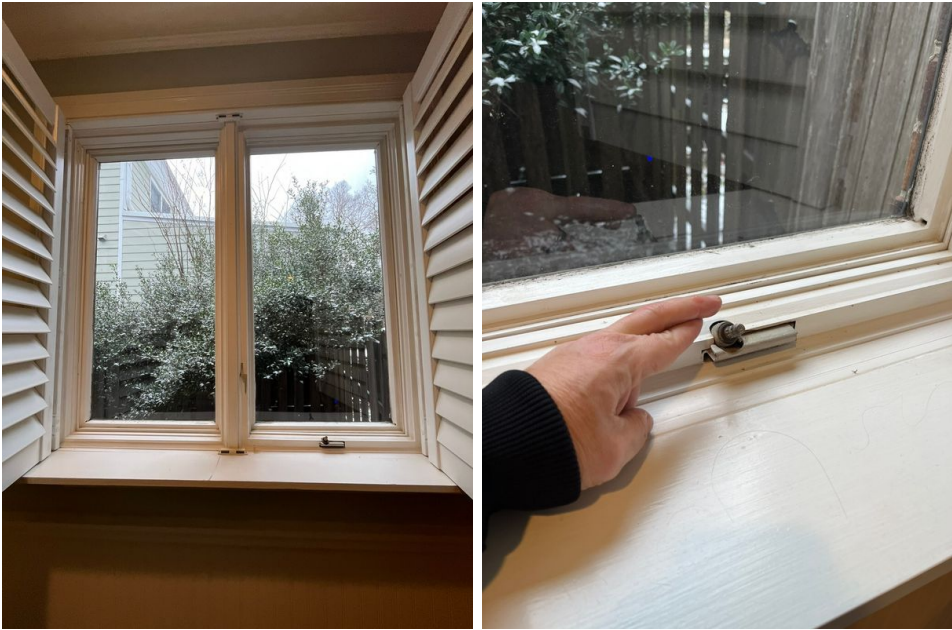
DAMAGED HARDWARE AT WINDOW

I observed damage to the hardware at a window.

Contact a qualified window repair/installation contractor.

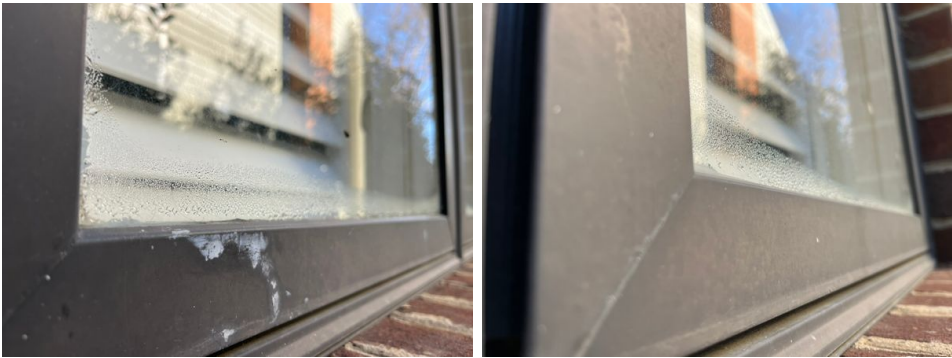
12.2.2 Windows

FOGGED / BROKEN SEAL

I observed a fogged window and broken seal that caused condensation between the window panes.

Contact a qualified window repair/installation contractor.

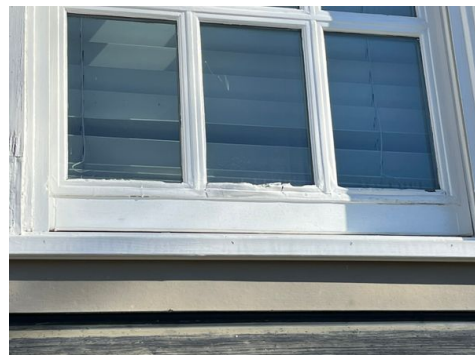
12.2.3 Windows

DAMAGED WINDOW

I observed damage to a window. This is the window that would not open in the 2nd floor guest bedroom. It is screwed shut.

Contact a qualified window repair/installation contractor.

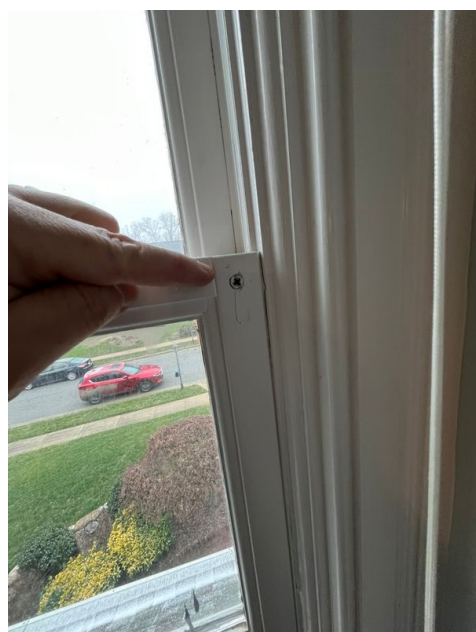
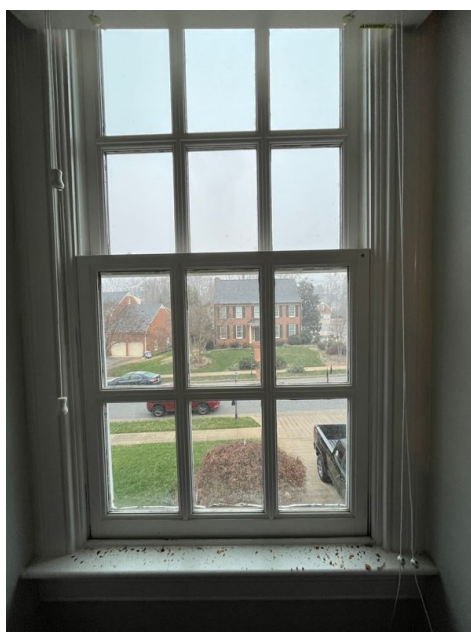
12.2.4 Windows

WINDOW WOULD NOT OPEN

I observed a window that would not open.

Contact a qualified window repair/installation contractor.

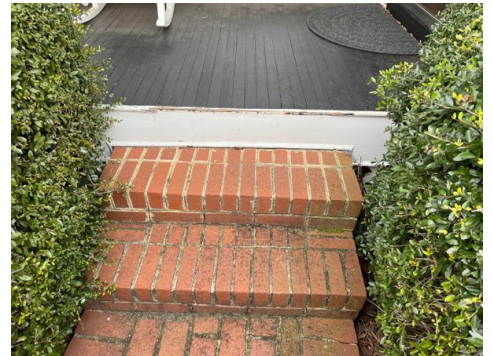
MISSING HANDRAIL

I observed a missing handrail.

There is more than one step here, and I recommend installing a handrail for safety.

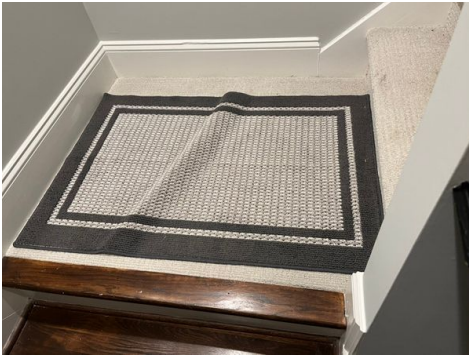
12.5.2 Stairs, Steps, Stoops, Stairways & Ramps

LOOSE CARPETING AT STAIRS

I observed indications of loose carpeting at the stairs.

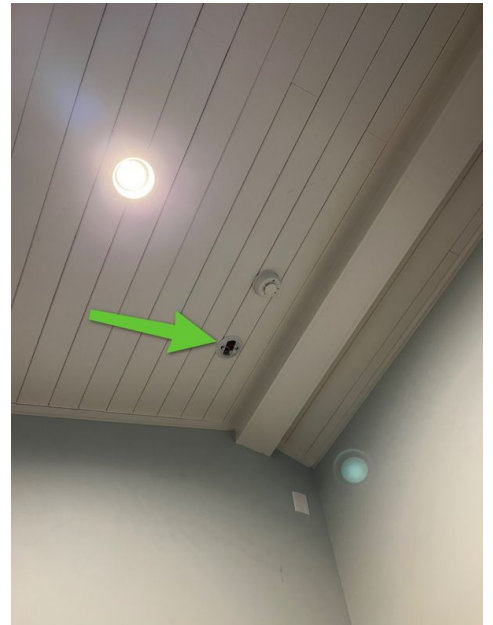
12.7.1 Presence of Smoke and CO Detectors

MISSING SMOKE DETECTOR

I observed indications of a missing smoke detector. Hazard.

Contact a qualified professional.
