BOLT CERTIFIED HOME INSPECTION

THE BOLT REPORT

7 Independence Ct
Greensboro, NC 27408

JANUARY 5, 2025

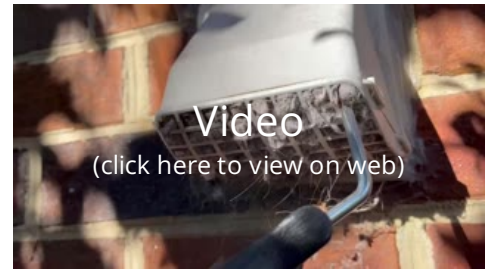
I observed indications of a clogged exhaust pipe of the clothes dryer.
Fire hazard.

Contact a qualified appliance repair professional.

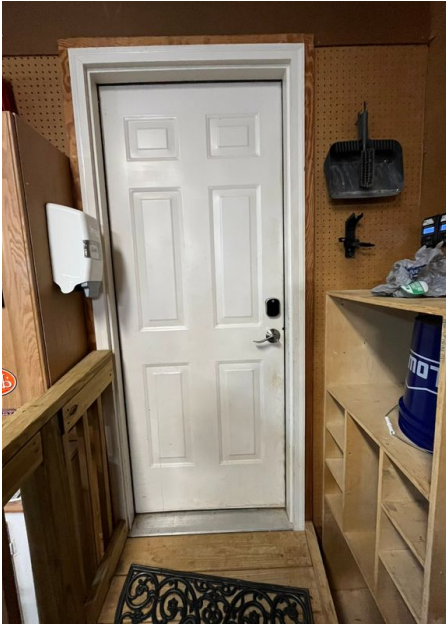
The door should be a solid wood door at least 1-3/8 inches thick, a solid or honeycomb-core steel door at least 1-3/8 inches thick, or a 20-minute fire-rated door.

The door should be equipped with a self-closing or an automatic-closing device.
